SOUTH WESTMONT BUSINESS DISTRICT TAX INCREMENT FINANCING DISTRICT ELIGIBILITY FINDINGS

Village of Westmont, Illinois

October 1, 2012

Prepared by Teska Associates, Inc.

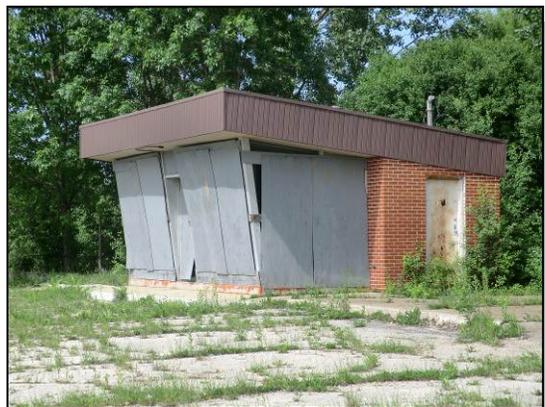
Currently, 5 structures (12%) in the Project Area display this extreme physical state. As illustrated in Map 3, these structures are characterized by severe deficiencies in structural systems, such that re-use is likely possible only by extensive renovation. Therefore, additional building analysis will be needed to determine if dilapidation contributes to the designation of the Project Area.

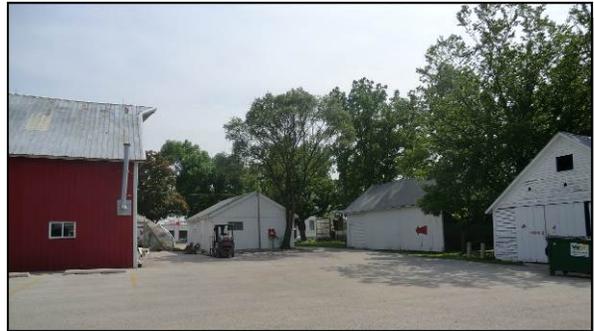
Within the Project Area, 20 buildings (47%) are functionally obsolete, involving 8 blocks (80%). These structures were generally found to no longer have the capacity to function effectively for their original intended use, are not consistent with current development trends or zoning, nor do they conform to current business requirements. **The number of blocks and parcels exhibiting this condition establishes obsolescence as a contributing factor towards designation of the Project Area as a blighted area.** Map 4 illustrates the presence and distribution of the obsolescence eligibility factor.

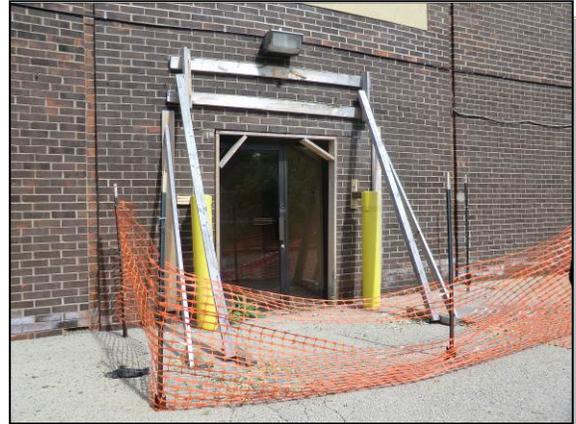
Deterioration of structures occurs on 21 of 43 parcels (49%), and is found throughout the Project Area, including all blocks (100%). Often the age of the structure is a primary factor in the deterioration of many structures, as the effects of time have not been arrested by private investment in maintenance. While the lack of property maintenance has contributed to deterioration of certain structures, vacancies in some structures also contribute to the deteriorated state, as tenants are not available to effect improvements.

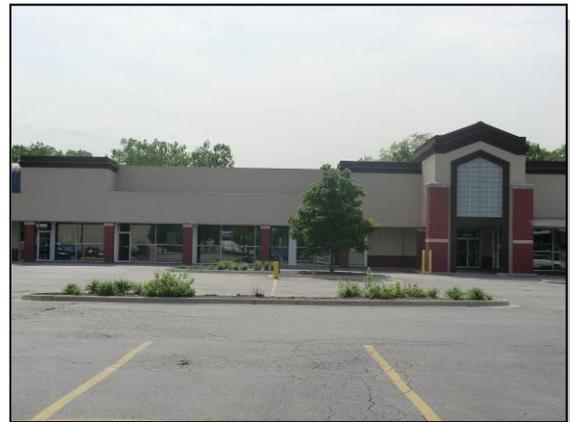
The conditions of roadways, alleys, curbs, gutters, sidewalks, off-street parking and surface storage areas may also evidence deterioration through surface cracking, crumbling, potholes, depressions, flooding, loose paving materials, and weeds protruding through the surface. Deteriorated surface improvements are apparent on 35 of 43 parcels (81%) and all blocks (100%). Broken and cracked sidewalks and deterioration of surface improvements occurs on individual properties, particularly in parking lots with degraded pavement and drainage systems.

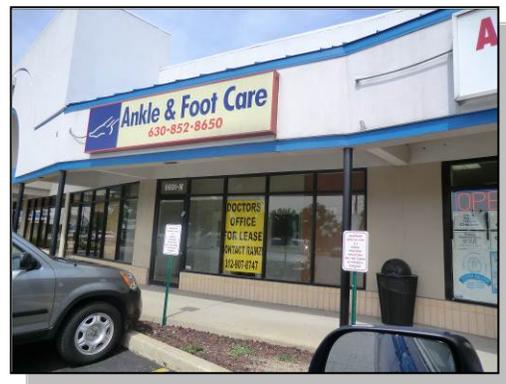
Within the Project Area 12 of 43 parcels (28%) and 4 of 5 blocks (80%) include structures that are presently vacant or partially vacant. Furthermore, vacancies occur within several large developments within the Project Area. Deterioration, code violations, and the age of structures are often associated with vacant structures. Continued vacancies are often related to the expense and difficulty of renovations that would be required in order to occupy these structures again.

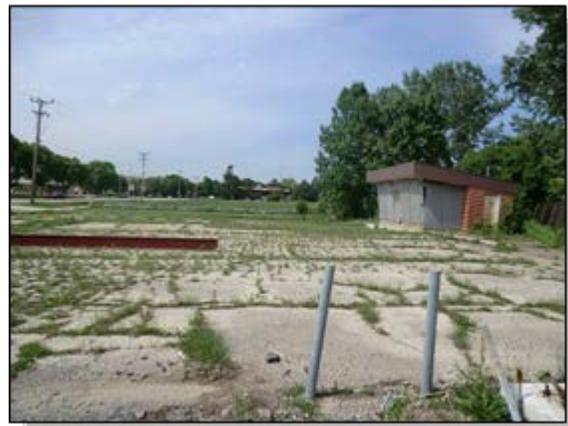
The Comprehensive Plan for the Village of Westmont was not adopted until 1982. As previously discussed, many properties developed prior to the adopted plan.

As shown in the Existing Land Use Map 10, the Project Area is characterized by a prominent mix of uses, including some that are incompatible with adjacent uses. For example, large format industrial sites were developed adjacent to residential neighborhoods. Currently, industrial uses do not conform to Village plans and commercial zoning for the Project Area that promotes expanding retail uses. Furthermore, many parcels are of irregular size and shape and are inadequate to meet needs of current businesses, providing further evidence of the lack of logical planning. Within the Project Area 30 of 43 parcels (70%) and 4 of 5 blocks (80%) contain parcels that exhibit lack of planning.

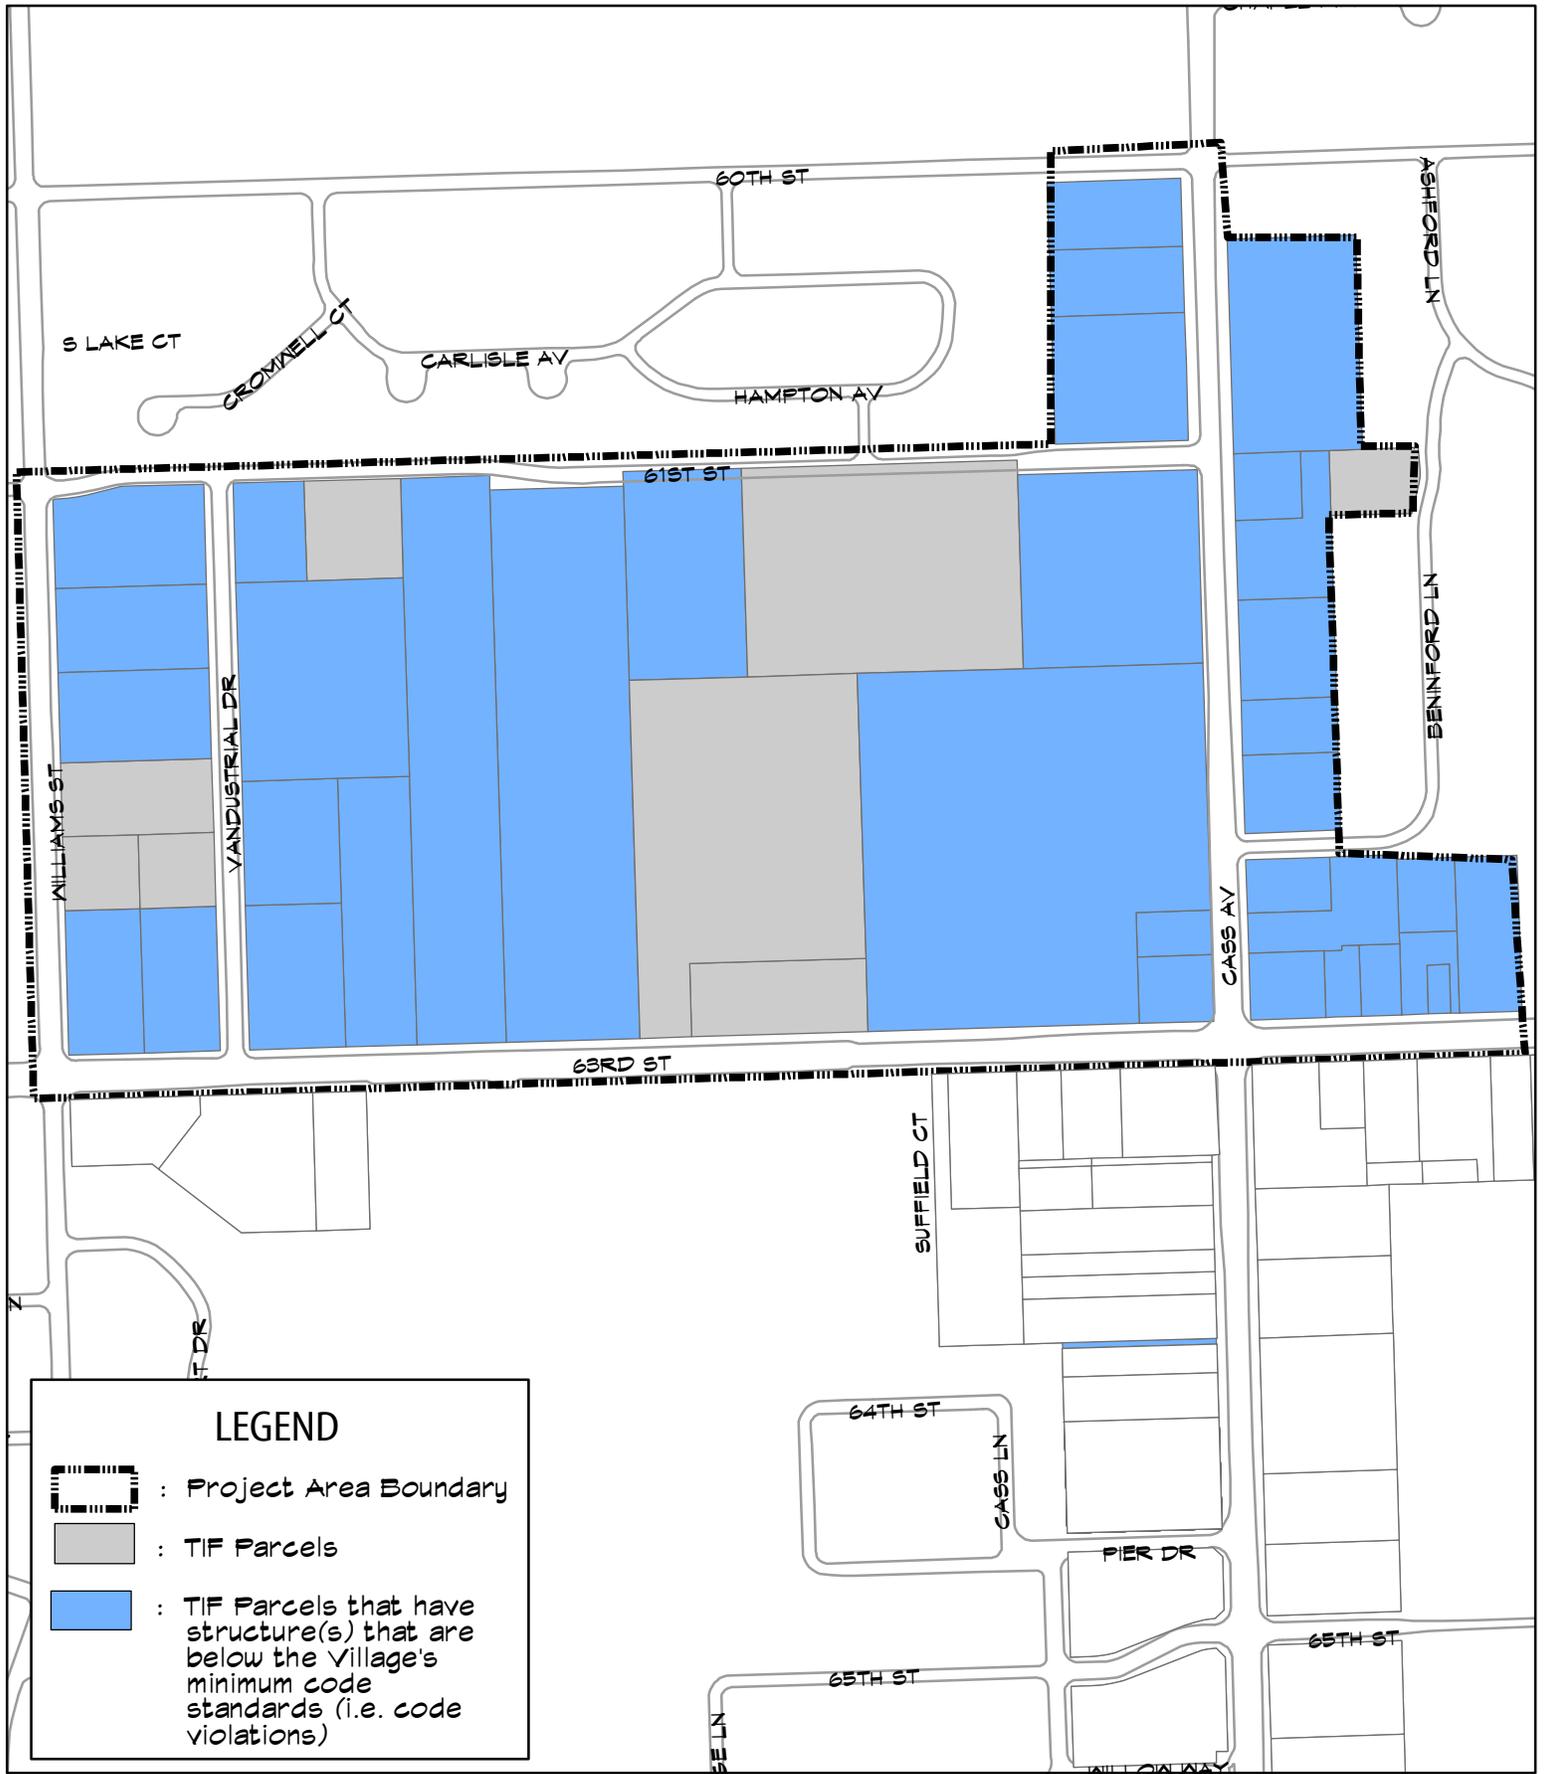
Map 6
TIF Eligibility Factor: Structures Below Minimum Code Standards

According to information provided by the Village of Westmont, 35 of 43 parcels (81%), and all blocks (100%) in the Project Area are not in compliance with Village or other government codes. Map 6 illustrates the location and distribution of this factor. Most non-compliant structures contain significant structural and site deficiencies. **The extent and distribution of structures below minimum code standards make a significant contribution to the designation of the Project Area as a blighted area.**

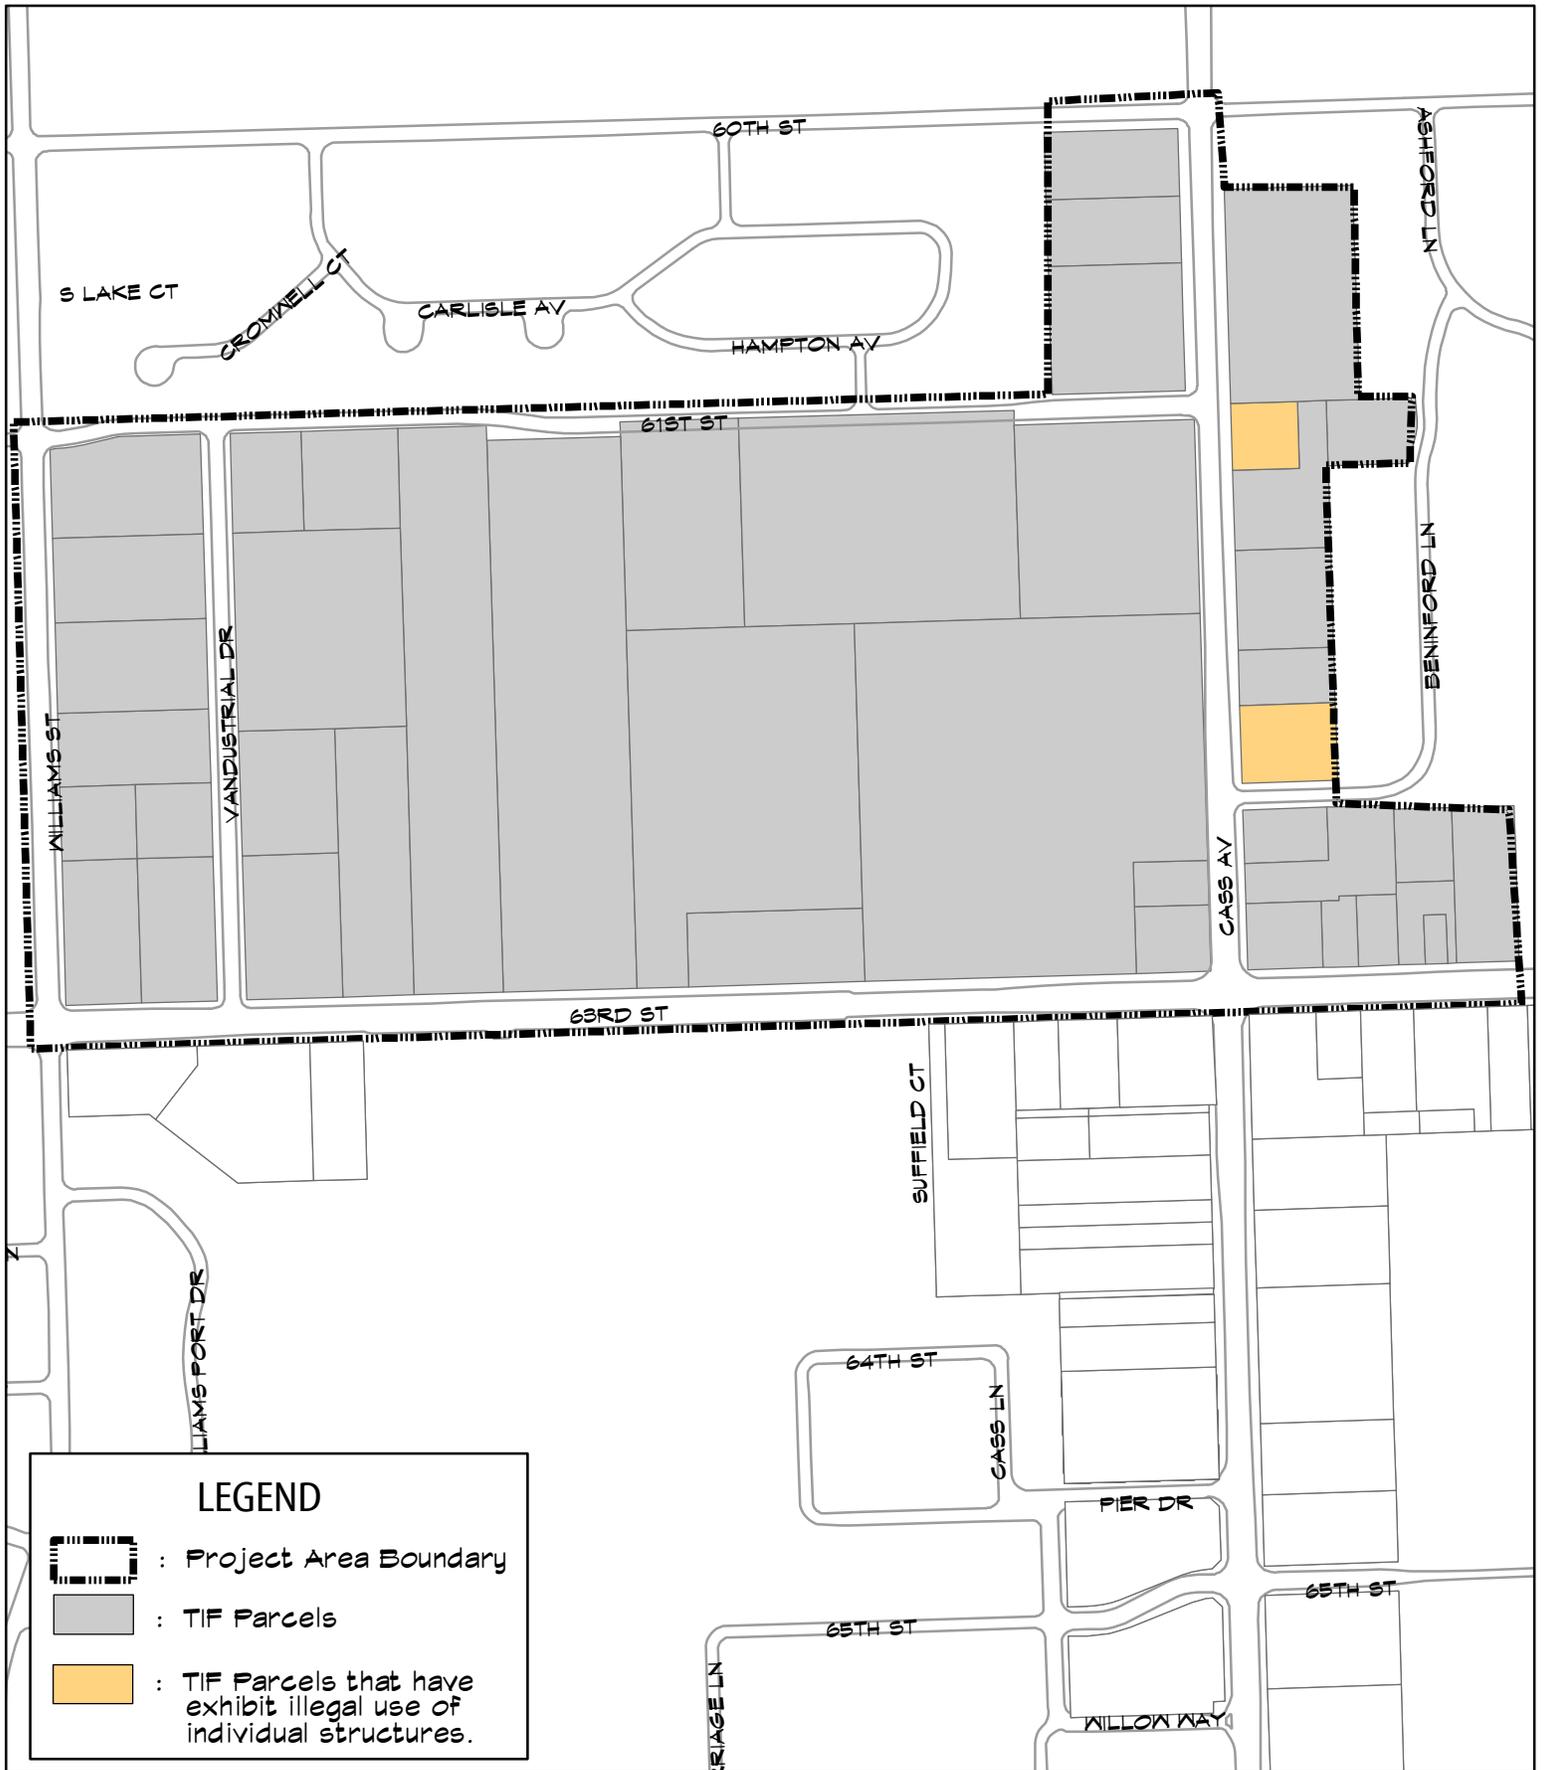
According to information provided by the Village of Westmont, 2 of 43 parcels (5%), and 1 of blocks (20%) in the Project Area are not in compliance with Village or other government regulations. Map 7 illustrates the location and distribution of this factor. The extent and distribution of structures exhibiting illegal use within buildings does make a significant contribution to the designation of the Project Area as a blighted area.

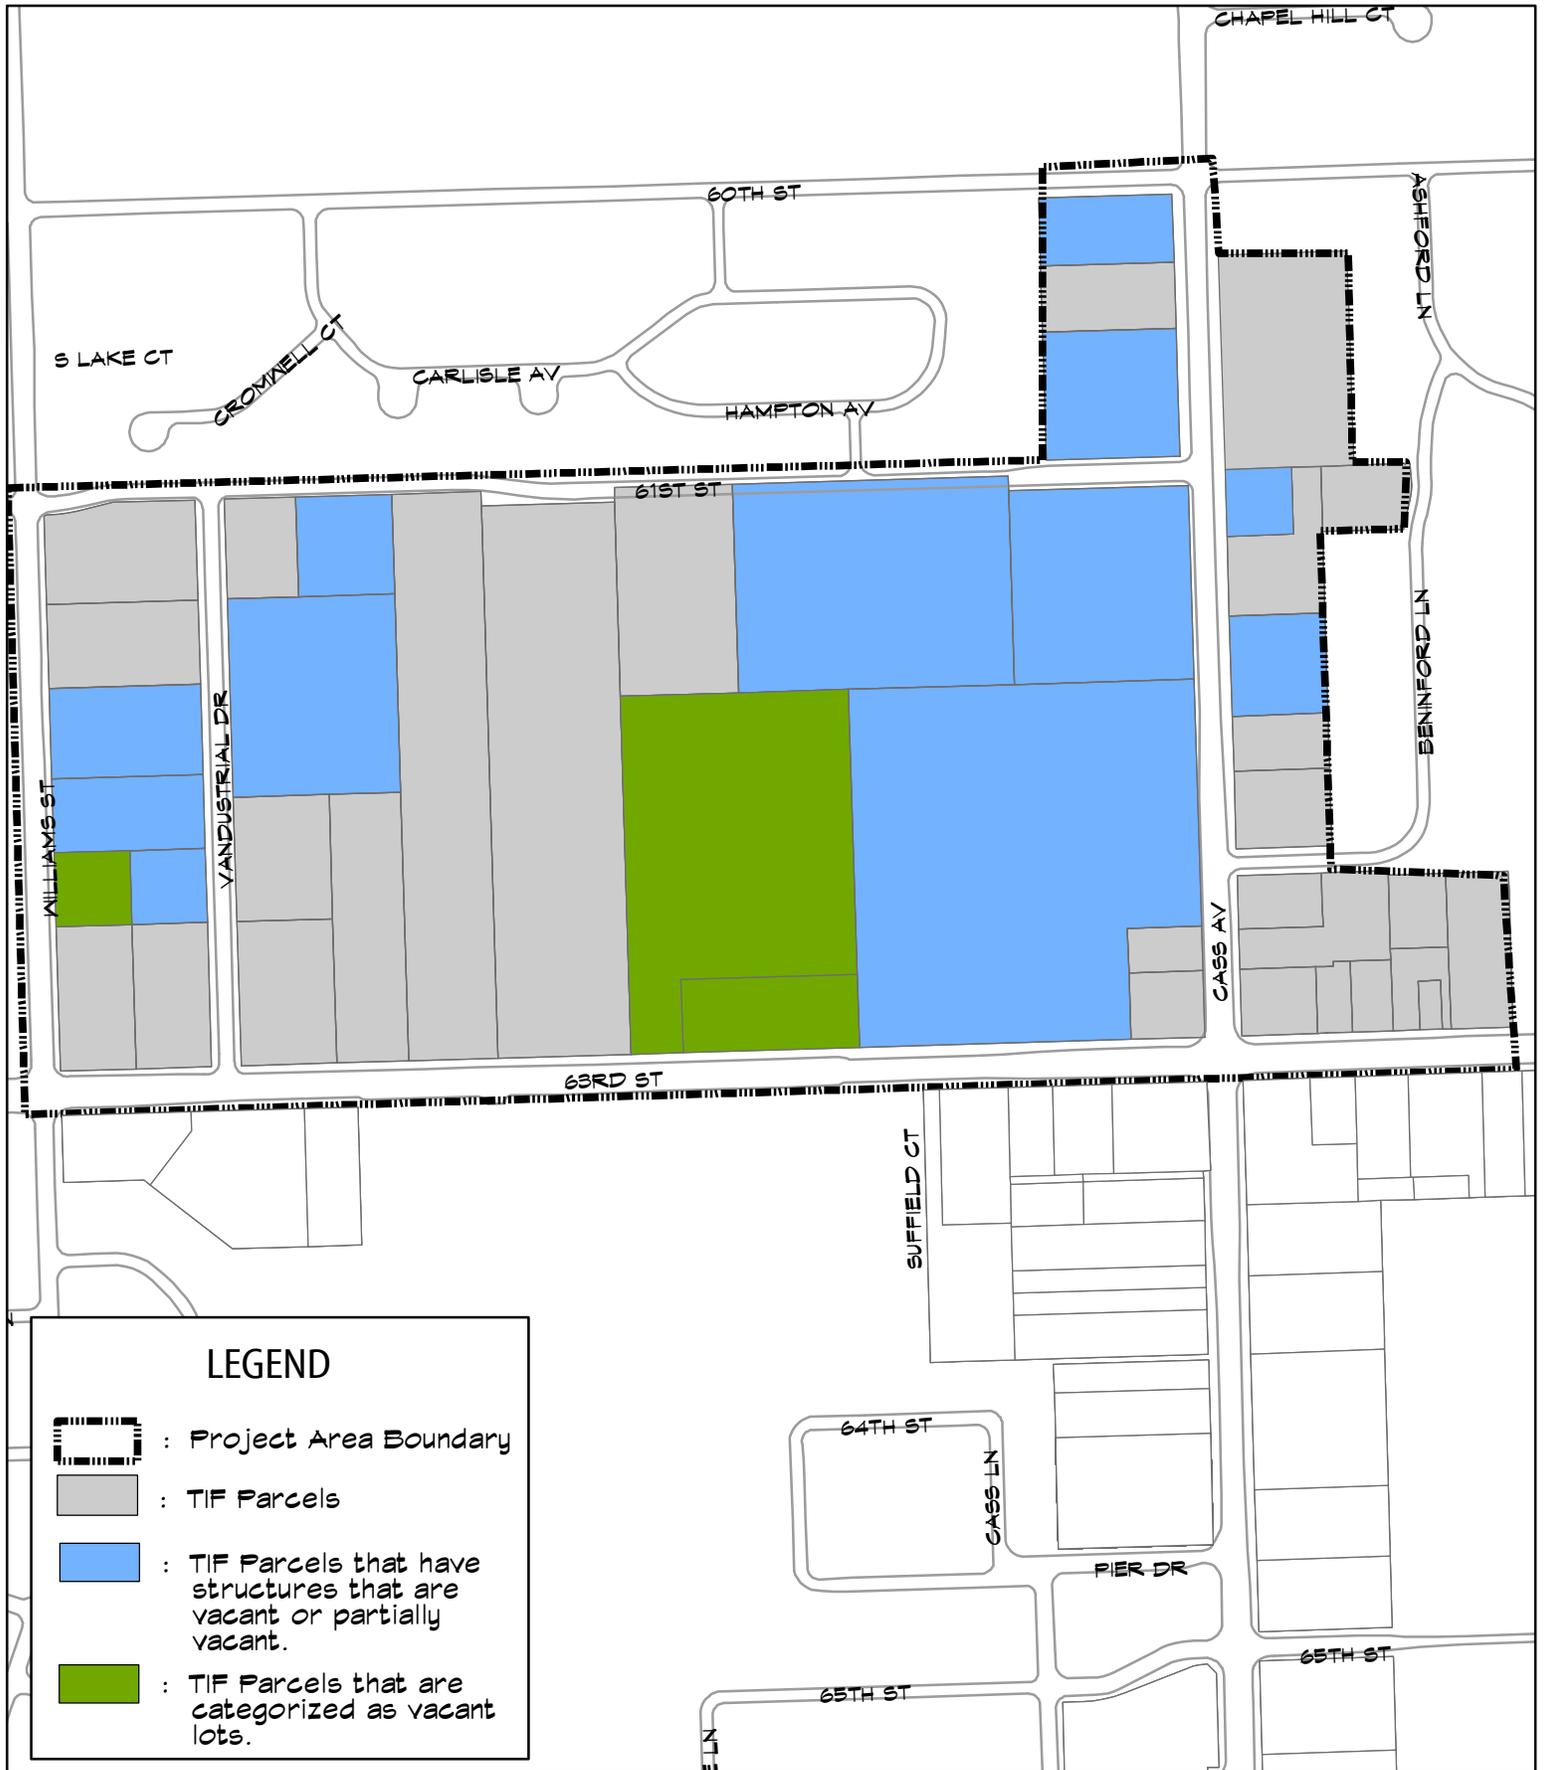
Map 8
TIF Eligibility Factor: Vacancies

The extensive presence of vacant buildings and portions thereof, and the amount land involved establish that vacancies are a significant contributor to the eligibility of the Project Area being designated as a blighted area. Although the presence and distribution of vacant lots do not contribute to TIF eligibility, the conditions of many of the vacant lots help qualify the Project Area as a blighted area by way of site deterioration, as noted above. If left untended, other vacant lots could also deteriorate. Map 8 illustrates the presence and distribution of the vacancy eligibility factor.

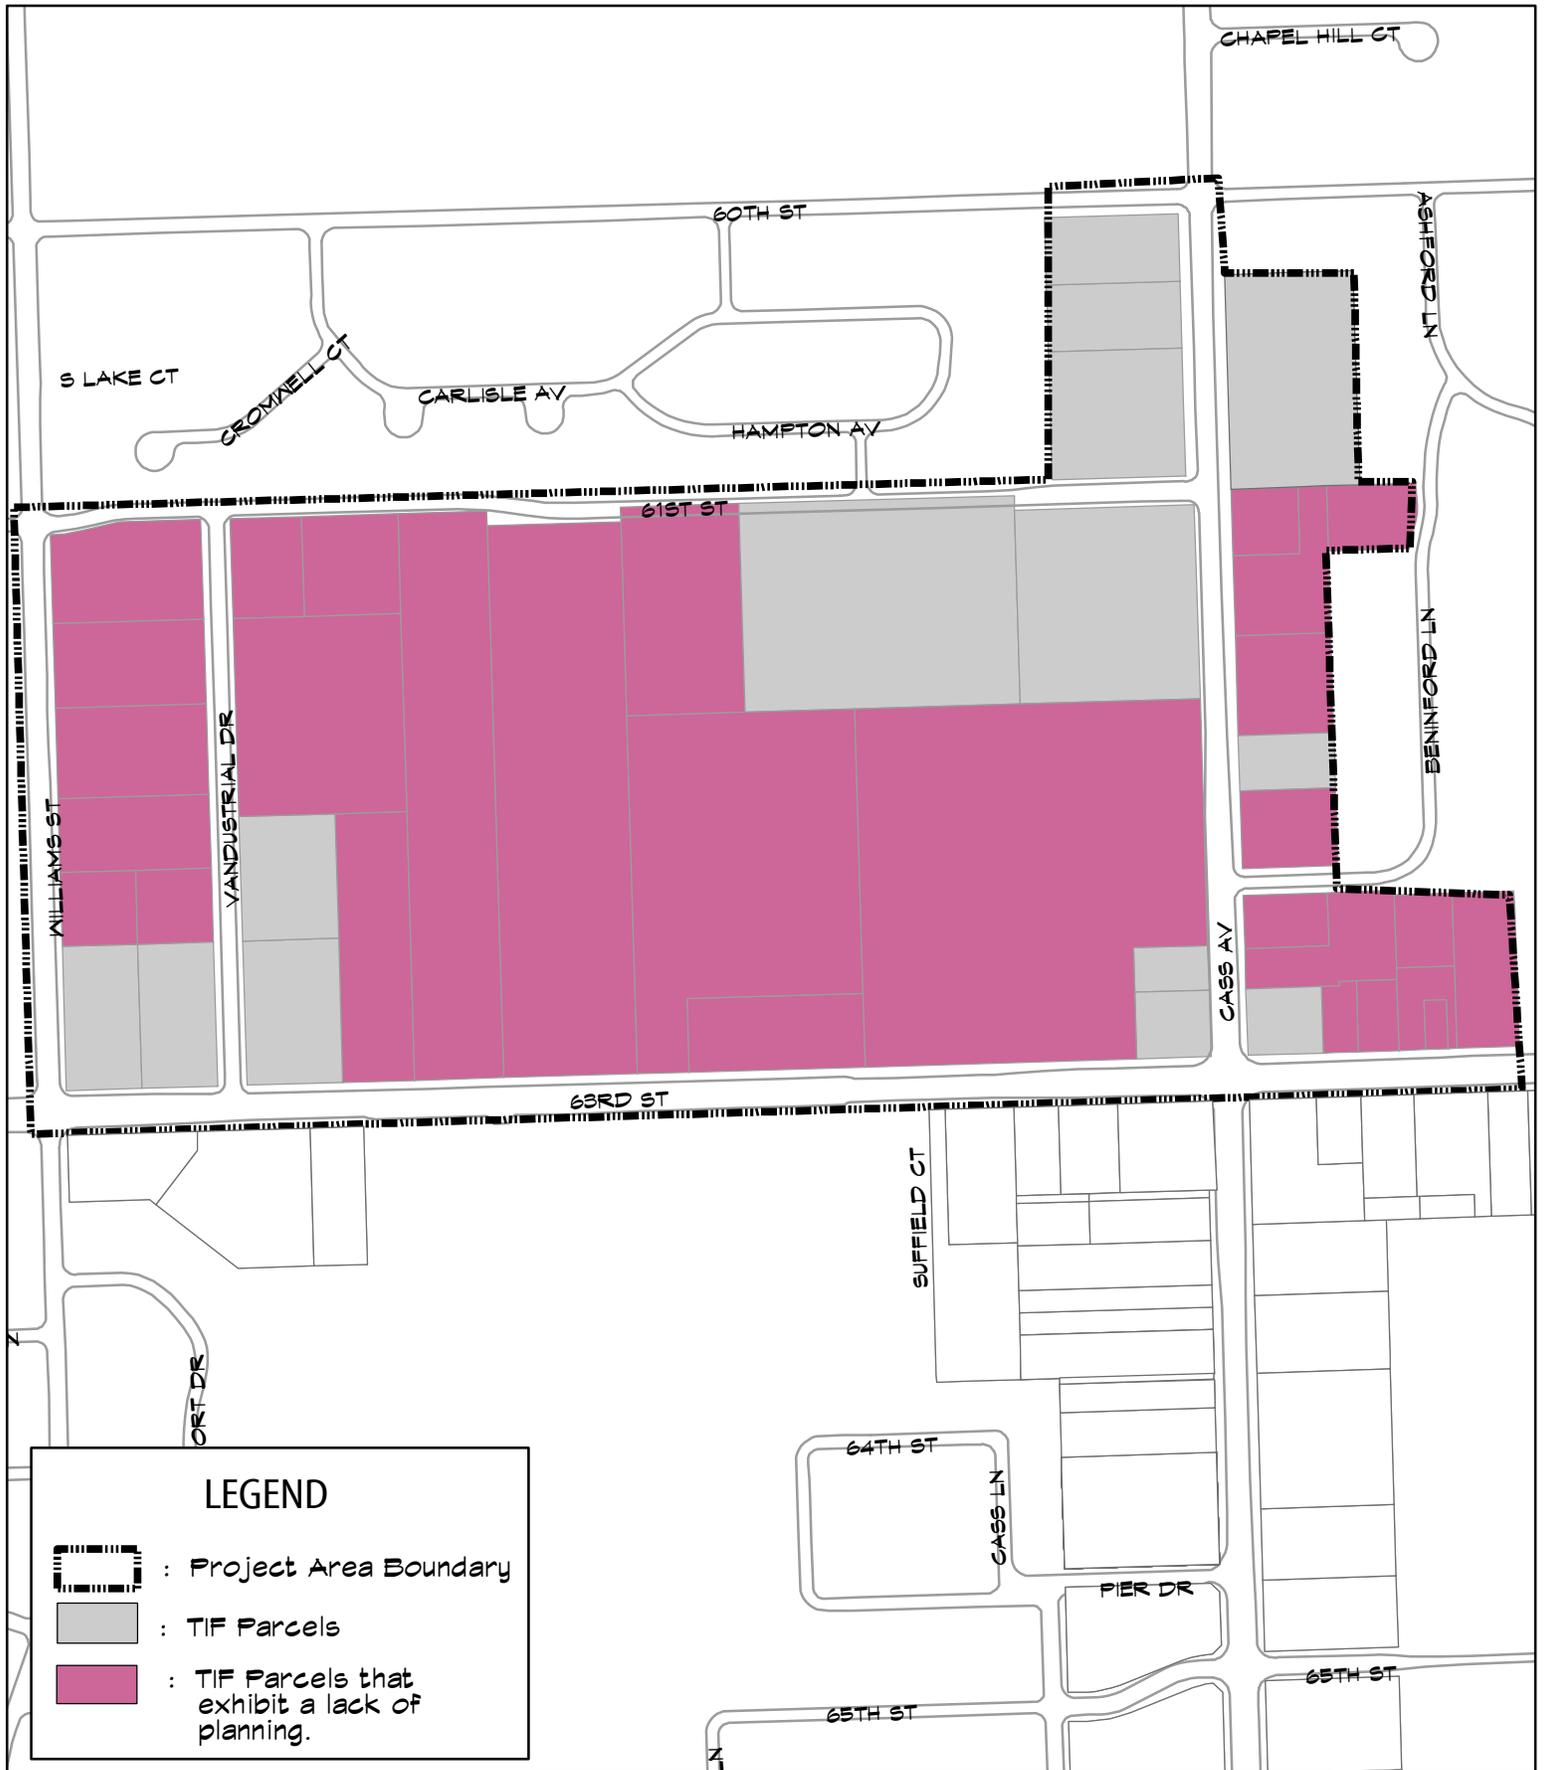
Map 9
TIF Eligibility Factor: Lack of Planning

Given the presence of these factors, lack of community planning is a contributing factor to the blighted area designation of the Project Area. Map 9 illustrates the presence and distribution of lack of planning.
