Central Business District Tax Increment Financing District Central Business District Eligibility Findings Report

Village of Westmont, Illinois

PRELIMINARY DRAFT

September, 2012

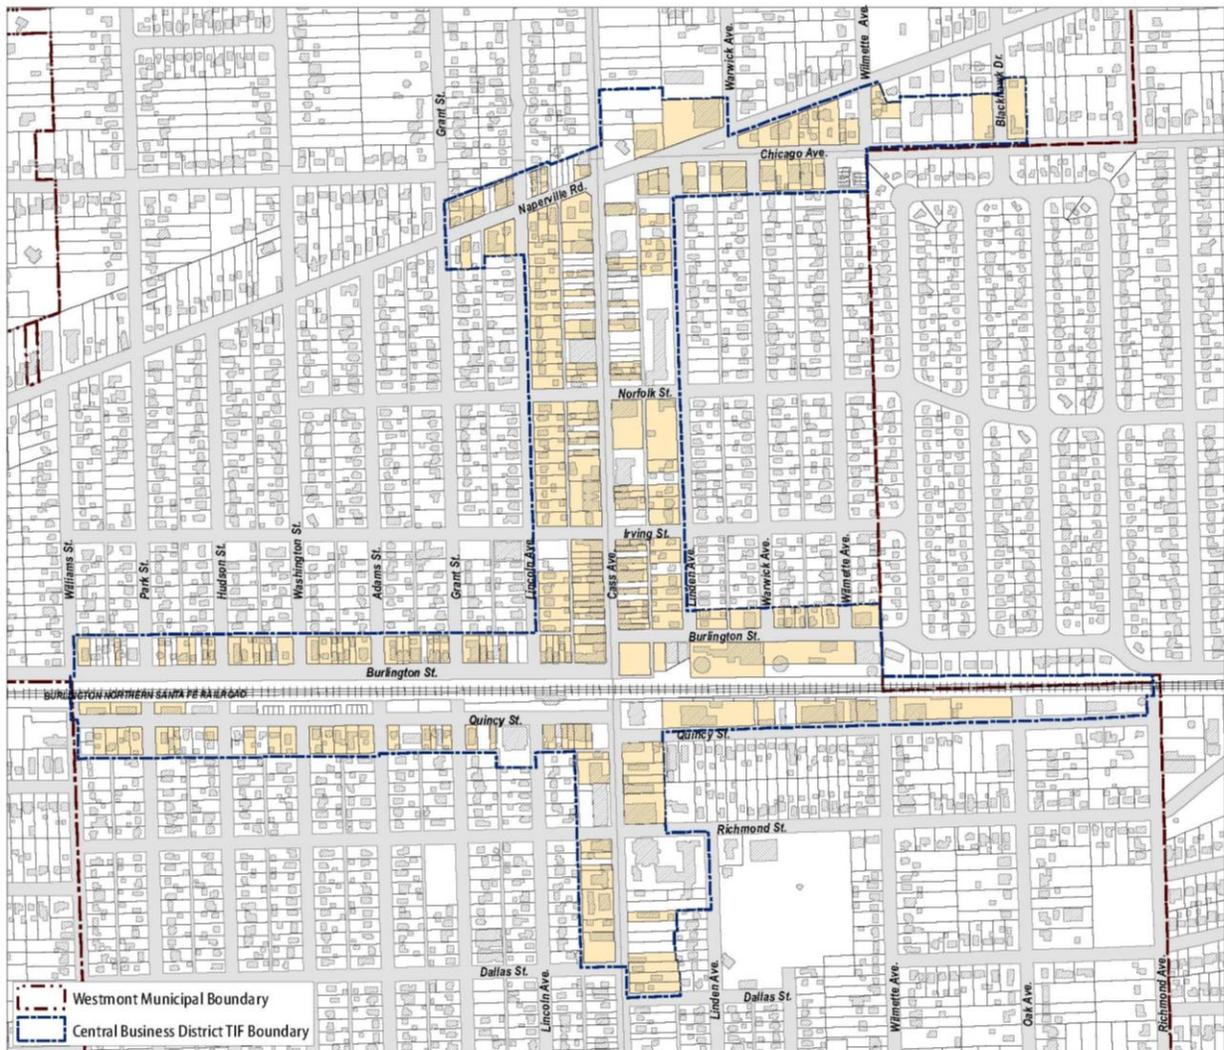
Map 2: Parcels that have buildings more than 35 years old.

Based on historical and property records provided by the Village of Westmont and obtained from the Downers Grove Township website, 245 out of 296 (83%) of the primary structures and 245 out of 446 (55%) of all the structures in the Project Area are more than 35 years old. Map 2 illustrates the distribution of these parcels. **Therefore, the Project Area meets the age factor of more than 50% of the structures being 35 years old or older, and qualifies to be designated as a 'conservation area.'**

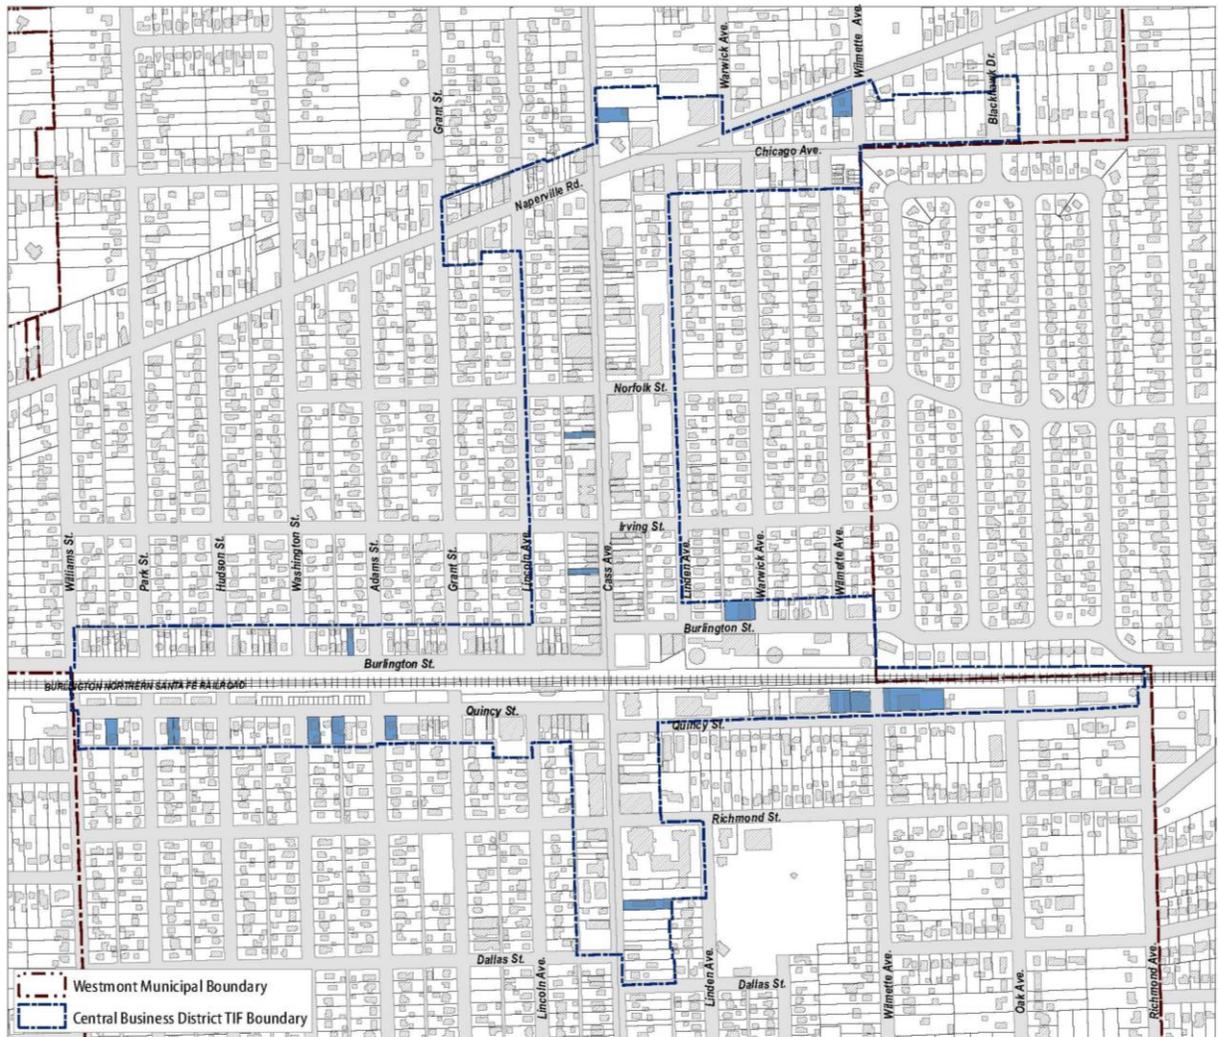
Map 3: Map showing the dilapidated parcels.

Currently, 14 structures (5%) in the Project Area display this extreme physical state. As illustrated in Map 3 and the pictures below, these structures are characterized by severe deficiencies in structural or mechanical systems, such that re-use is possible only by extensive renovation. The distribution of these structures is dispersed throughout the study area, but a large number are to the south of Quincy Street. However, as the percentage of dilapidated buildings is small, it is not significant enough factor to designate the Project Area as a conservation area.

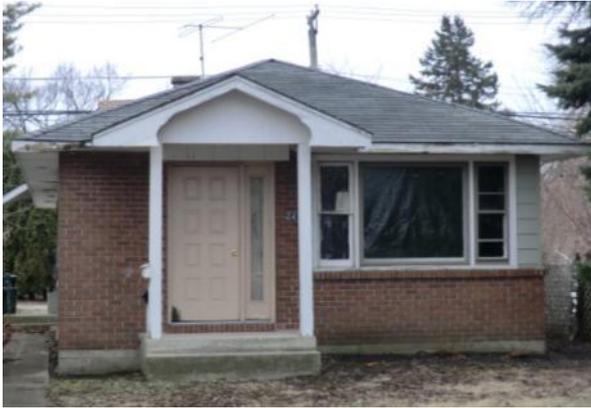
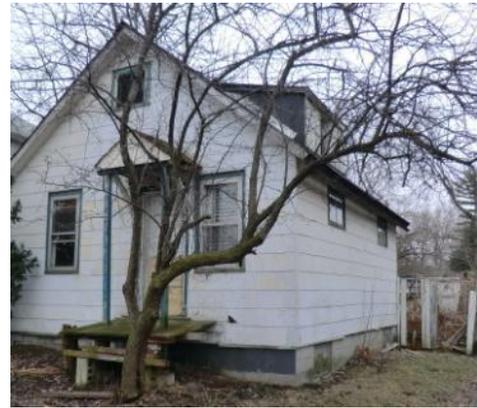
Pictures showing houses within the Study Area that are in a dilapidated condition

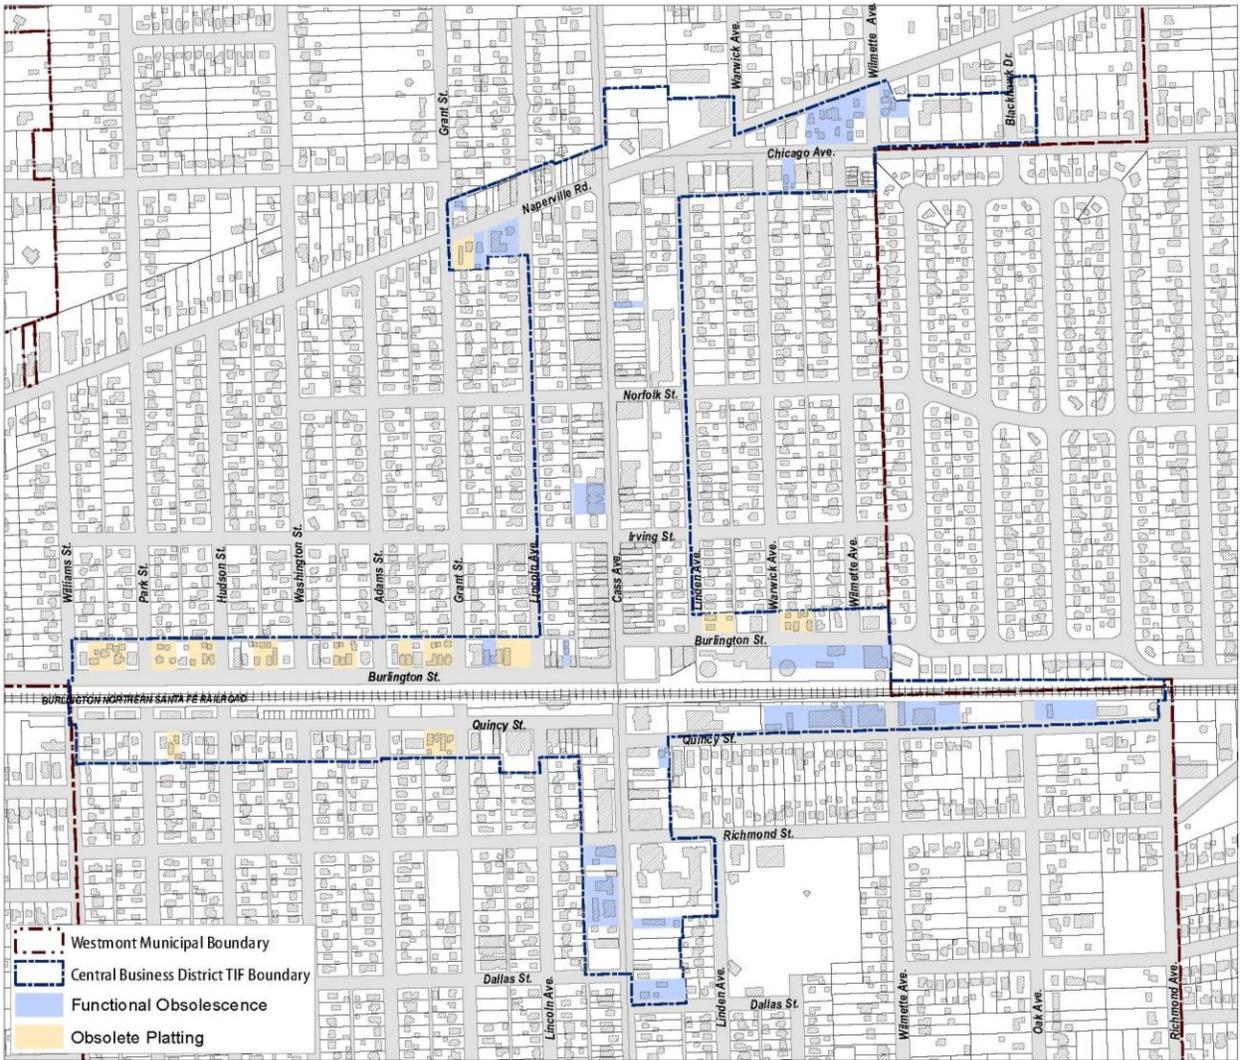
Map 4: Map showing parcels that are obsolescent.

Therefore, obsolescence in all 3 relevant categories (functional, site improvements and platting), was found to be a significant contributing factor toward the designation as a conservation area and their distribution is shown in the map below.

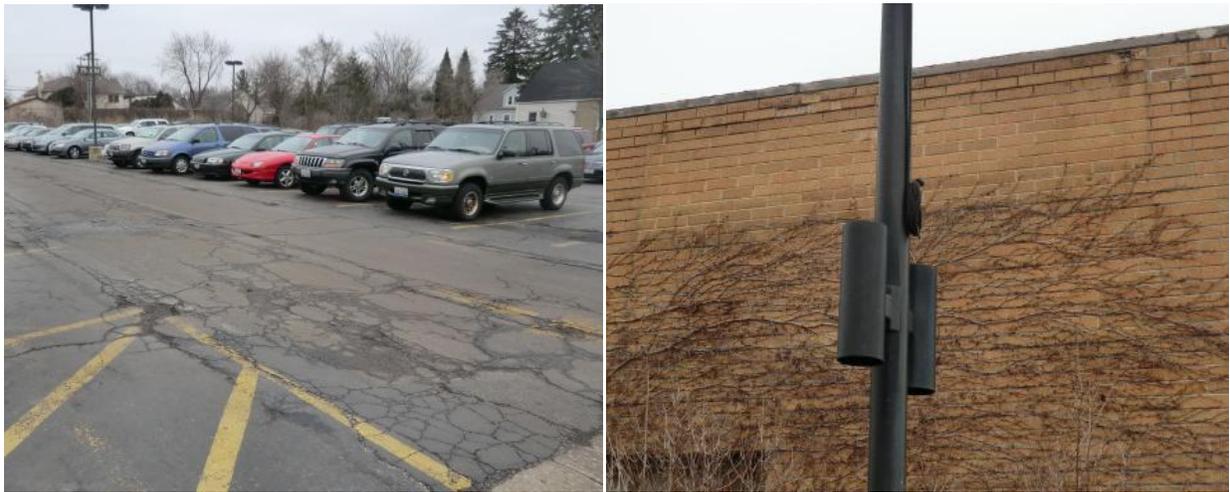
Pictures showing deterioration of a parking area and the parapet wall of a building

Deterioration of structures occurs on 208 of 296 parcels (70%), and is found throughout the Project Area. Often the age of the structure is a primary factor in the deterioration of many structures, as the effects of time have not been arrested by private investment in maintenance. Property maintenance could be a contributing factor to deterioration of certain structures, vacancies in some structures also contributes to the deteriorated state, as tenants are not available to effect improvements.

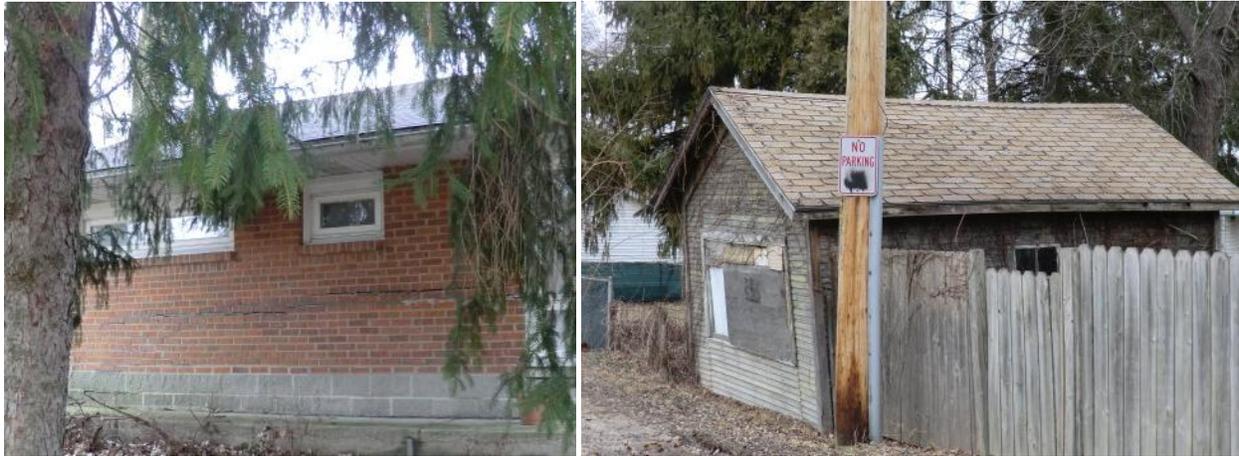
When looked at jointly, the number of parcels showing deterioration (to either the structure or surface improvement) is significant- 283 of 406 total parcels (70%) and is illustrated on Map 5. **This widespread extent and distribution of deterioration of both structures and surface improvements with the entire Project Area makes deterioration a contributing factor towards designation of the Project Area as a conservation area.**

Pictures showing major structural deterioration

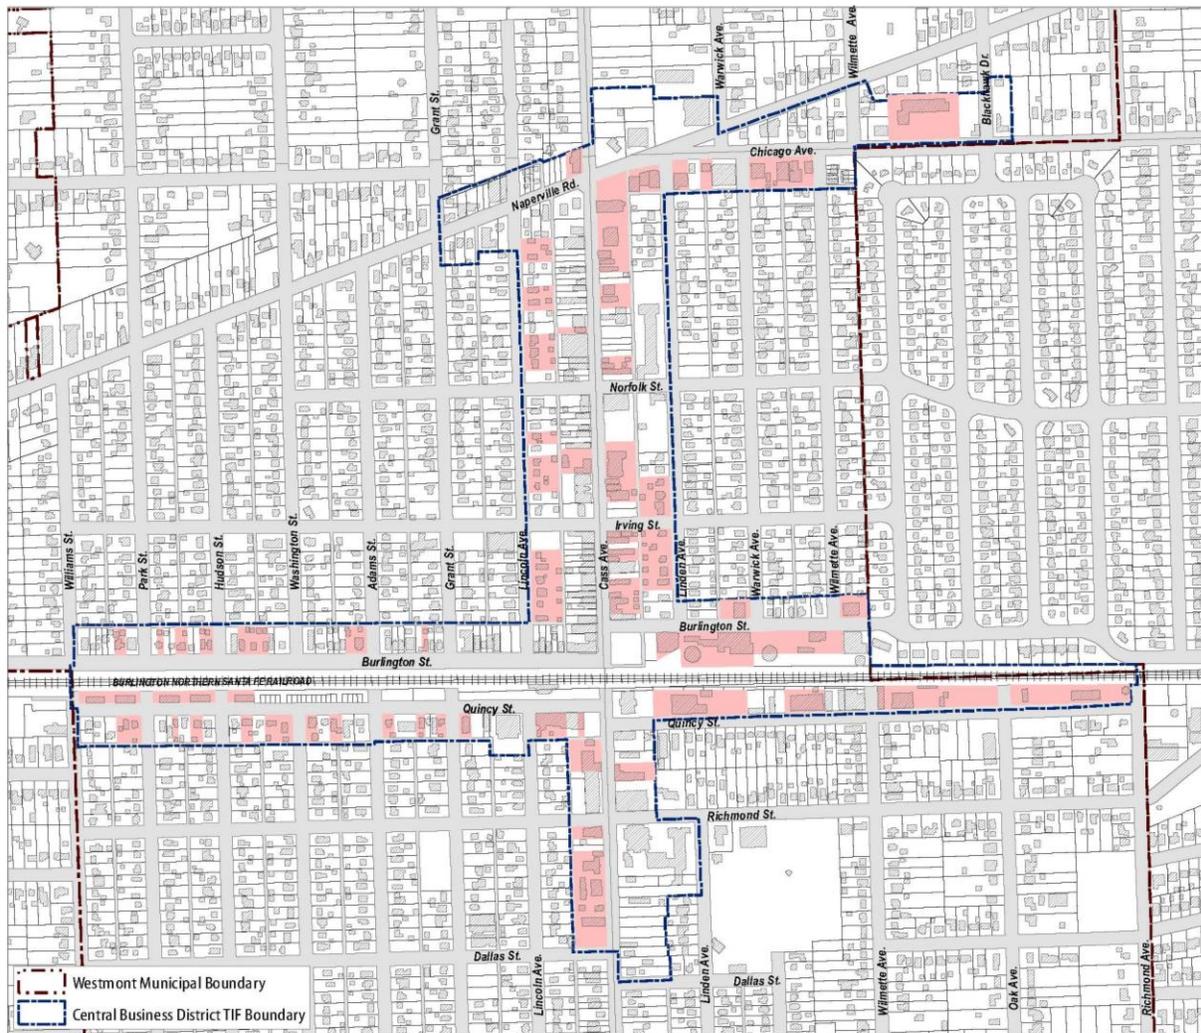
Map 6: Map showing the distribution of parcels below minimum code.

According to information provided by the Village of Westmont, as well as the site visit observations, 131 of 296 parcels with structures (44%) in the Project Area are not in compliance with zoning, fire or other codes mentioned above. Map 6 illustrates the location and distribution of this factor. **The extent and distribution of structures below minimum code standards make a significant contribution to the designation of the Project Area as a conservation area.**

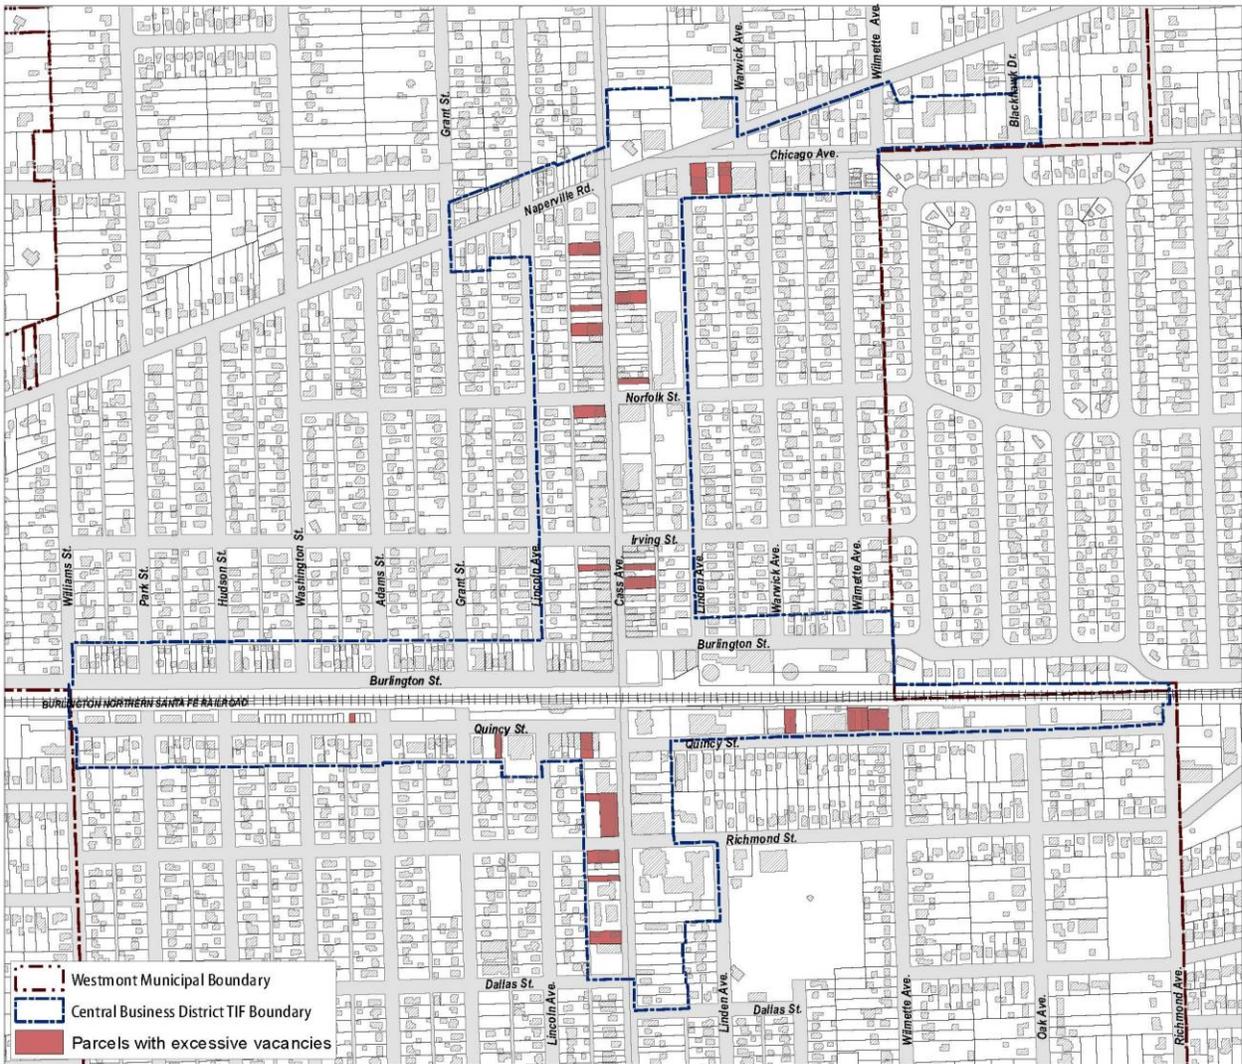
Map 7: Map showing parcels with excessive vacancies.

Within the Project Area 20 of 296 parcels (7%) include structures that are presently vacant or partially vacant. Deterioration, code violations, and the age of structures are often associated with vacant

structures. Continued vacancies are often related to the expense and difficulty of renovations that would be required in order to occupy these structures again. These vacancies however are well distributed among the central business district parcels along Cass Avenue and Quincy Street, but are not well distributed among the residential parcels. Hence, it cannot be used as a significant contributing factor for the eligibility of the Project Area as a conservation area. Although the presence and distribution of vacant lots do not contribute to TIF eligibility, the conditions of many of the vacant lots help qualify the Project Area as a conservation area by way of site deterioration, as noted above. If left untended, other vacant lots could also deteriorate. Map 7 illustrates the presence and distribution of the vacancy eligibility factor.

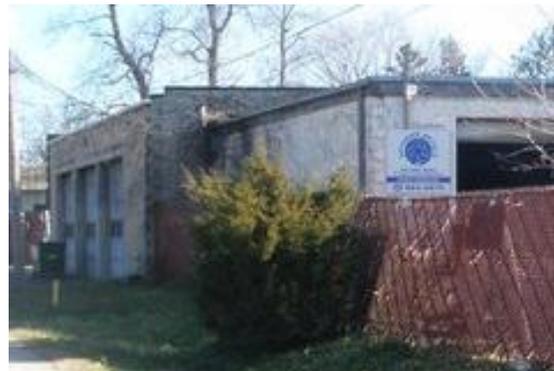
One such parcel was observed within the Project Area exhibit noxious fumes being emitted from the building and was across from a residential parcel. Therefore deleterious land use or layout does not make a significant contribution to the classification of the entire Project Area as a conservation area.
