# **SOUTHWEST WESTMONT BUSINESS DISTRICT TAX INCREMENT FINANCING DISTRICT ELIGIBILITY FINDINGS**

**Village of Westmont, Illinois**

**FINAL DRAFT**

Prepared by Teska Associates, Inc.

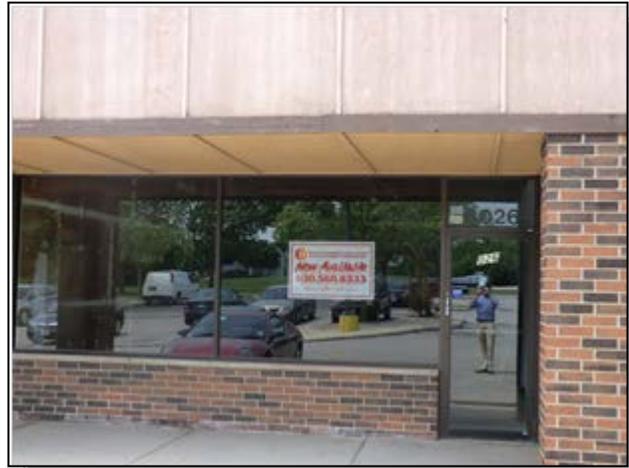
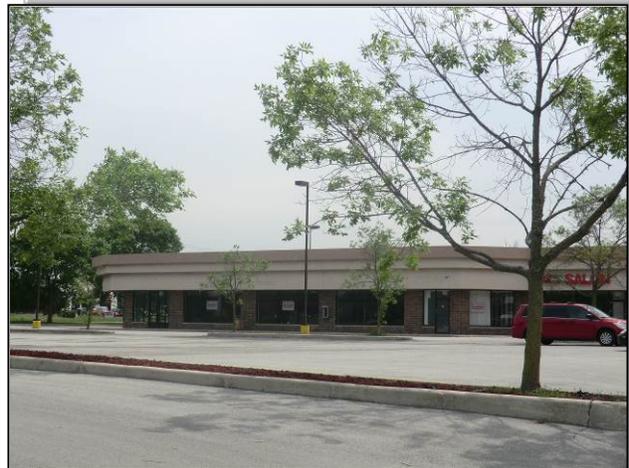
Overall, the present condition and mix of land uses, and configuration of parcels within the Project Area contributes to the decline of the Village's tax base, inhibits redevelopment potential, and negatively impacts on properties within and near the Project Area. Lack of adequate maintenance of properties and excessive vacancies have a blighting influence on properties within the Project Area, resulting in limited investment, and large commercial parcels that remain either under-utilized or vacant. Due to their age many deteriorated buildings fall below modern building code standards and require costly rehabilitation. As such, many buildings have outlived their useful life and are obsolete for modern uses. Further, the presence of vacant lots, some on large sites and in visible locations, contribute to an overall poor image and have a negative impact on nearby properties. These conditions if not corrected will contribute to the continued decline of the Project Area, which further inhibits investment, resulting in future decline. The next section elaborates further on the nature and extent of the specific conditions which contribute to the decline of the area.

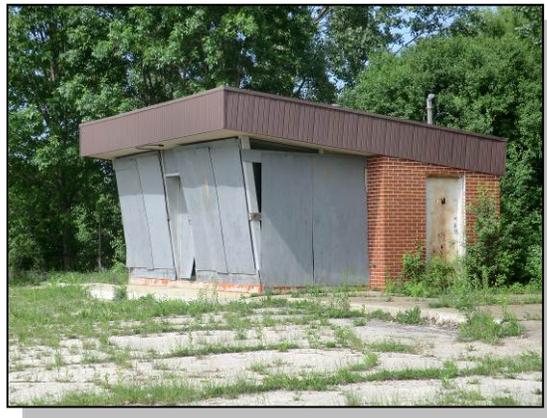
Currently, 5 structures (6%) in the Project Area display this extreme physical state. As illustrated in Map 3, these structures are characterized by severe deficiencies in structural or mechanical systems, such that re-use is possible only by extensive renovation. Therefore, dilapidation does not contribute to the designation of the Project Area.

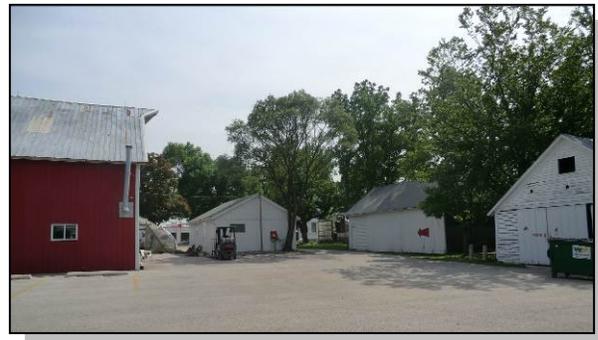
Within the Project Area, 28 buildings (33%) are functionally obsolete, involving 8 blocks (62%). These structures were generally found to no longer have the capacity to function effectively for their original intended use, are not consistent with current development trends or zoning, nor do they conform to current business requirements. **The number of blocks and parcels exhibiting this condition establishes obsolescence as a contributing factor towards designation of the Project Area as a blighted area.** Map 4 illustrates the presence and distribution of the obsolescence eligibility factor.

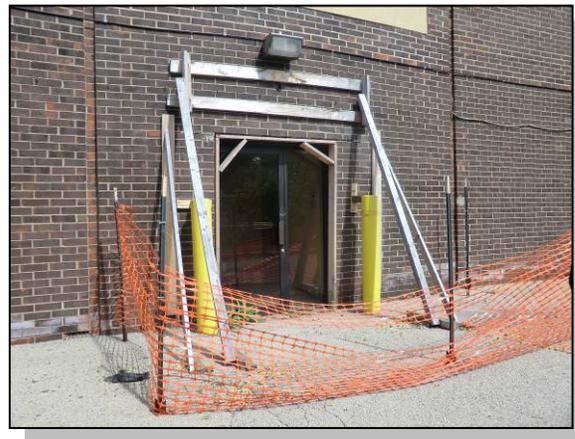
Deterioration of structures occurs on 31 of 85 parcels (36%), and is found throughout the Project Area, including 10 of 13 blocks (77%). Often the age of the structure is a primary factor in the deterioration of many structures, as the effects of time have not been arrested by private investment in maintenance. While the lack of property maintenance has contributed to deterioration of certain structures, vacancies in some structures also contribute to the deteriorated state, as tenants are not available to effect improvements.

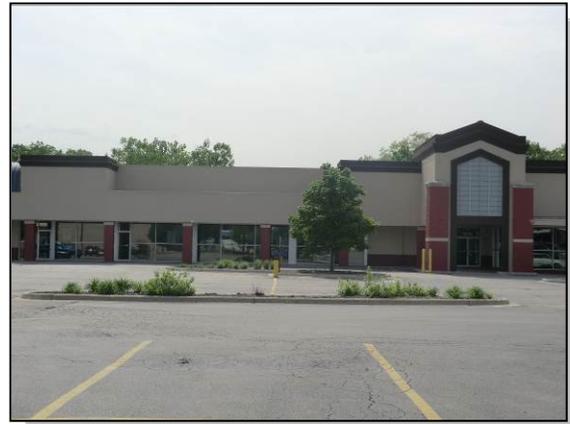
improvements are apparent on 64 of 85 parcels (75%) and 11 of 13 blocks (85%). Broken and cracked sidewalks and deterioration of surface improvements occurs on individual properties, particularly in parking lots with degraded pavement and drainage systems.

As illustrated on Map 6, the widespread extent and distribution of deterioration of both structures and surface improvements creates a significant blighting effect upon the entire Project Area.

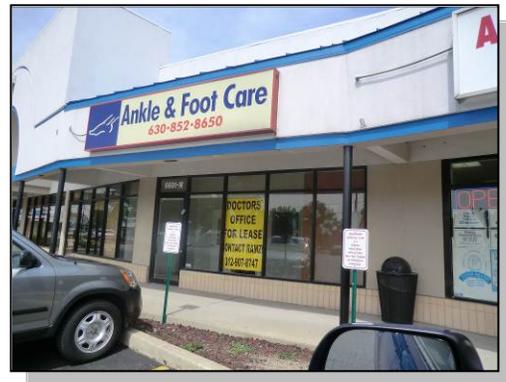
Within the Project Area 21 of 85 parcels (25%) and 7 of 13 blocks (54%) include structures that are presently vacant or partially vacant. Furthermore, vacancies occur within several large developments compromising 26% of the total land area within the Project Area. Deterioration, code violations, and the age of structures are often associated with vacant structures. Continued vacancies are often related to the expense and difficulty of renovations that would be required in order to occupy these structures again.

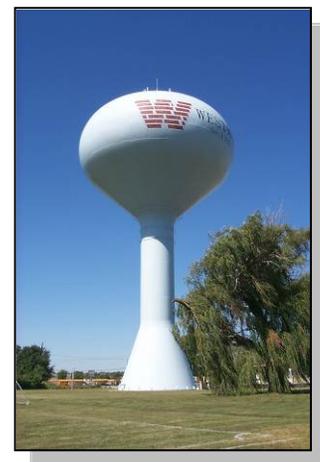
According to information provided by the Village of Westmont, most of the Project Area lacks adequate stormsewer and stormwater detention facilities, thereby contributing to flooding in area. Specifically, most of 63rd Street remains in rural cross section, lacking required curb and gutter and stormsewer to reduce flooding in the area. Existing detention facilities tributary to St. Joseph creek are insufficient and must be expanded/improved to reduce flooding. Several parcels along Vandustrial Drive lack adequate stormwater detention, including several large vacant parcels the Village is currently marketing for redevelopment. Inadequate stormwater facilities also occur on the Anchor Rock industrial park site on 65th Street causing flooding on streets.

Therefore, much of the Project Area lacks adequate stormsewers and stormwater management facilities due to age of the area. New water service improvements are required along 63<sup>rd</sup> Street to improve services to businesses and other uses south of 63rd Street. The Village plans to provide a parallel water main on the south side of 63rd Street to improve and upgrade services for properties south of 63rd Street. **The lack of adequate stormwater and water main services impacts the entire Project Area, and therefore the lack of adequate utilities is a significant factor in the designation of the Project Area as a blighted area.**

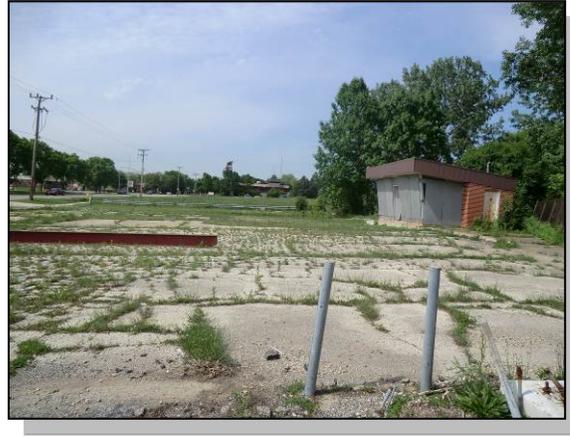
The Comprehensive Plan for the Village of Westmont was not adopted until 1982. As previously discussed, many properties developed prior to the adopted plan. As shown in the Existing Land Use Map 10, the Project Area is characterized by a prominent mix of uses, including some that are incompatible with adjacent uses. For example, large format industrial sites were developed adjacent to residential neighborhoods. Currently, industrial uses do not conform to Village plans and commercial zoning for the Project Area that promotes expanding retail uses. Furthermore, many parcels are of irregular size and shape and are inadequate to meet needs of current businesses, providing further evidence of the lack of logical planning. Within the Project Area 57 of 85 parcels (67%) and 8 of 13 blocks (62%) contain parcels that exhibit lack of planning. **Given the presence of these factors, lack of community planning is a contributing factor to the blighted area designation of the Project Area.** Map 9 illustrates the presence and distribution of lack of planning.
